September 21, 2026

### **Introduction**

At your request, I visited the Plainview CSD School in Plainview, NE on Wednesday September 9th, 2026. The intent of the site visit was to perform an in-depth structural assessment of the entire school building. It shall be noted that I originally visited the school in September 2024 to address an ongoing floor settlement issue. Please refer to that report dated 9/30/2024 for further information.

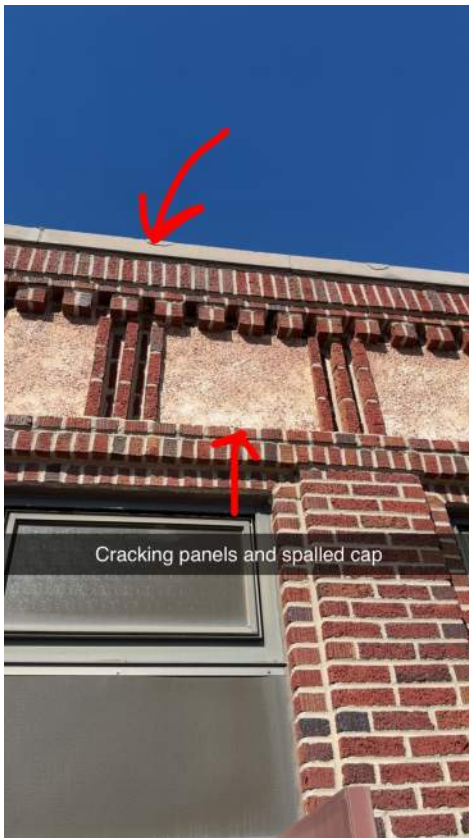
2. Exterior Conditions:
  - a. The exterior parapet continues to show signs of deterioration (Photos 1, 2 & 3). This was identified in the 2024 report.
    - i. The stone parapet cap shows several spalled sections. This was reported damage from the previous reroofing project. It appears that the anchorage system caused the outside corner to fracture in several locations.

PHOTO 1 - SOUTH PARAPET

- 2) While the exterior façade of the building still appears to be in structurally sound condition given the age of the building; any damaged or spalled masonry at the exterior of the building should be addressed in the near future. As the building goes through seasonal freeze/ thaw cycles, any damaged masonry will allow moisture to enter the building envelope and continue to deteriorate the exterior façade. Keeping ahead of moisture related deterioration will be key in the longevity of this building.

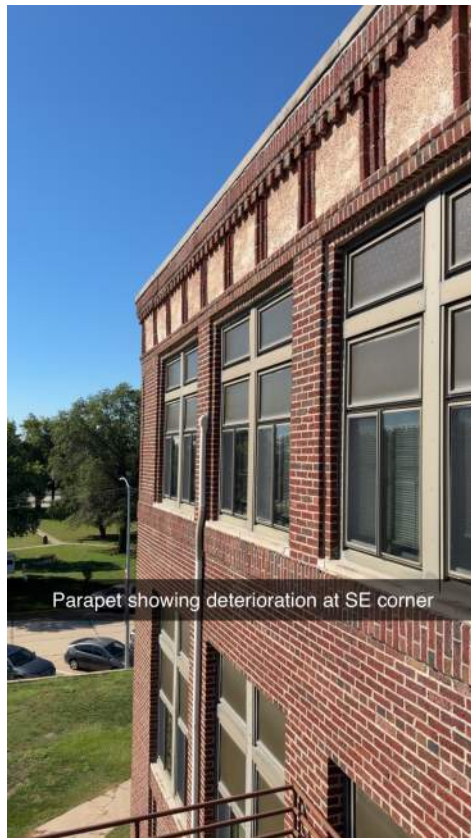
PHOTO 2 - SE PARAPET

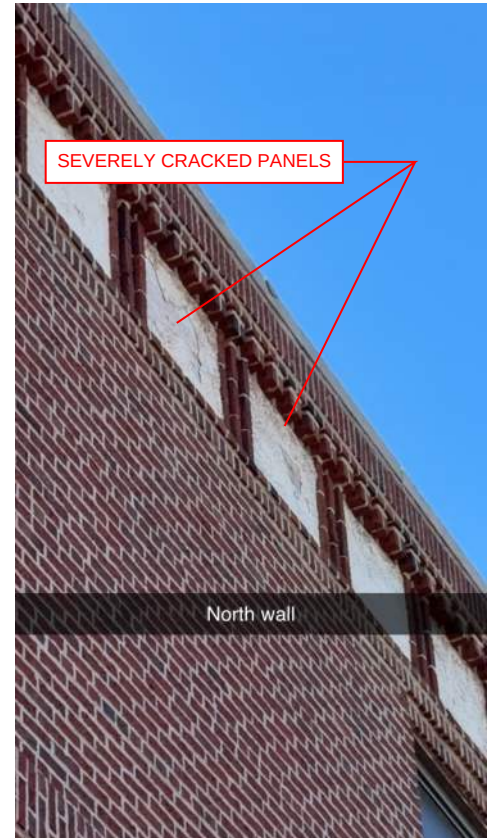
- ii. The cast stone square panels show cracking. The most severe location being the north parapet wall (Photo 3).
  - b. The loading dock retaining wall is deteriorating and starting to fail (Photo 4).

- a. As identified in Photo 3, it appears that the water infiltrated the exterior wall and created water damage on the interior face of the masonry walls. Gayle reported that the water damage has been since resolved.

PHOTO 3 - NORTH PARAPET

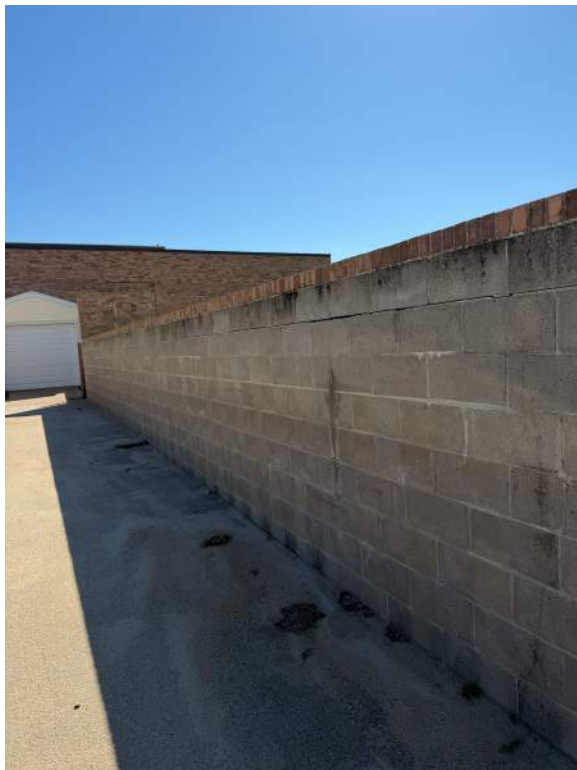
PHOTO 4 - LOADING DOCK RETAINING WALL

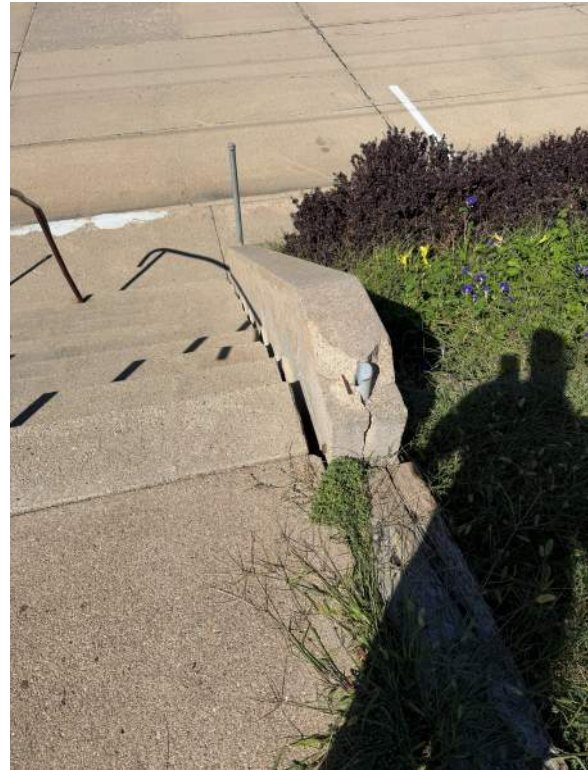
- c. Several stoops, stairs, and railings are showing signs of deterioration (Photos 5, 6, 7).
- 3. Wrestling Floor: It is my understanding that this was not an engineered & framed addition to the school (Photo 8).

PHOTO 5 - DAMAGED STAIRS/ RAILINGS

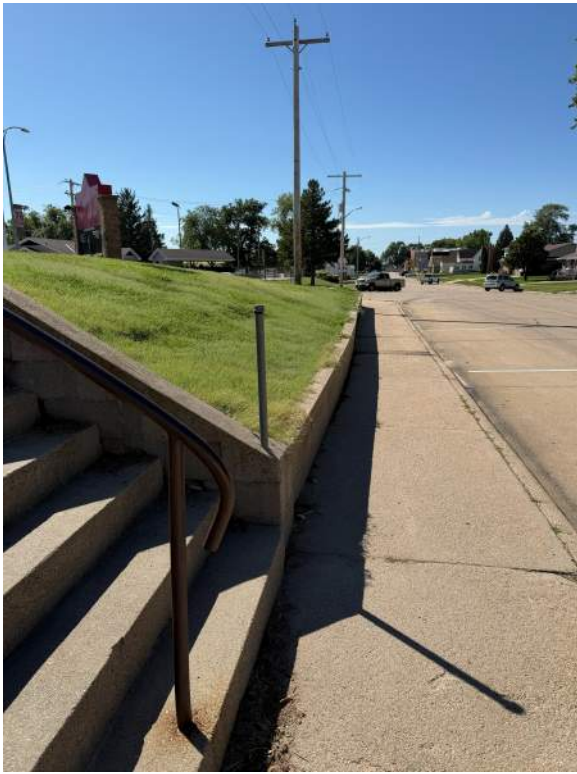
PHOTO 6 - LEANING RETAINING WALL

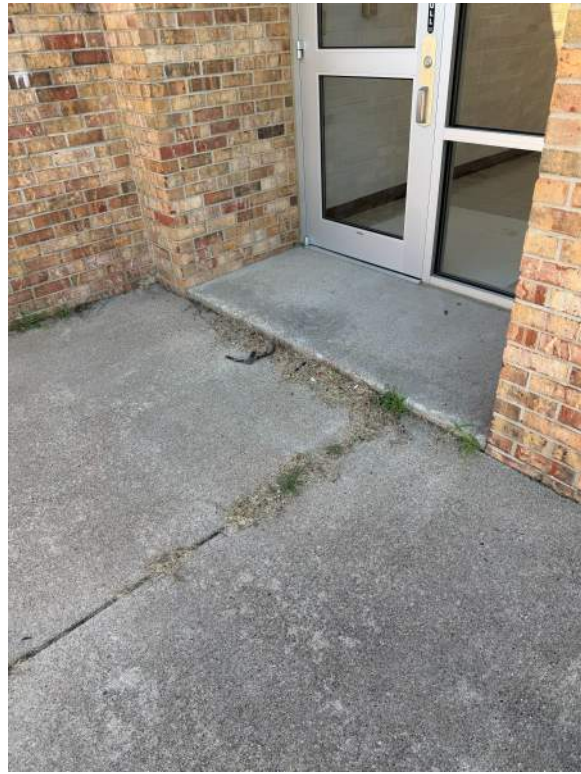
PHOTO 7 - NON-ADA COMPLIANT STOOP

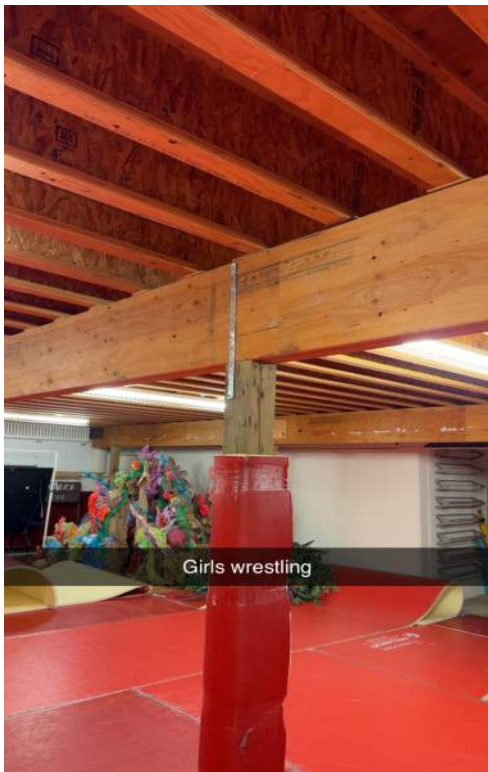
- a. I recorded measurements of the wood-framed existing structure reportedly framed 20+ years ago. The floor consists of 18" deep two and three-ply LVL primary beams, 6x6 timber columns at 16' centers, and 14" deep TJI joists spaced @ 16" centers. While I have no life safety concerns of the floor structure; depending on the grade of lumber used, these members may be undersized by 5%-15% by current design standards.

- b. The post to beam connections do not appear to use the appropriate connectors.
- 4. North Wall: Gayle pointed out that there has been water damage at the 3<sup>rd</sup> floor exterior wall (Photo 9).

PHOTO 8 - GIRL'S WRESTLING

- 3) While no immediate life safety concerns are present of the wrestling rooms; the girls wrestling room in the lower level is restricted by the column layout. Renovating the space to remove columns would likely require complete removal and reframing of the floor structure to ensure adequate head height clearance.

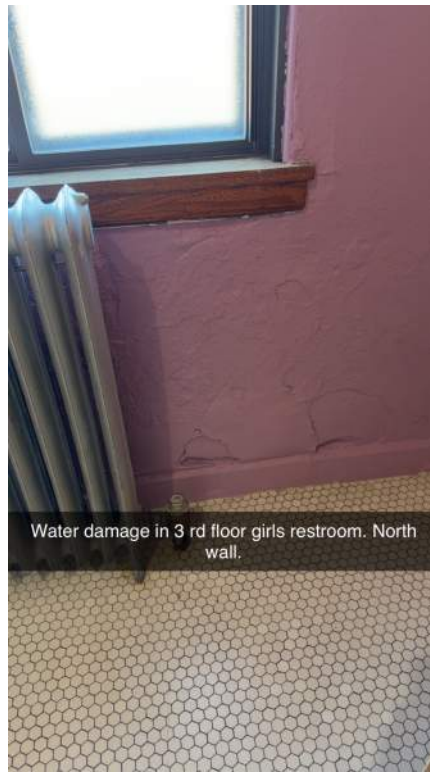
PHOTO 9 - WATER DAMAGE @ NORTH WALL

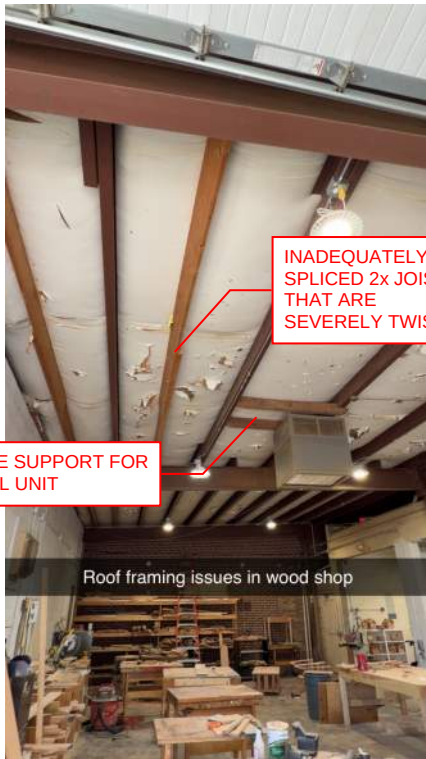
- 5. CTE/ Shop Structure: It appears that supplemental wood joists were added in an attempt to reinforce the roof structure. It is worth noting that the joists are spliced and midspan and are twisting (Photo 10).

- 4) The roof structure over the CTE / Shop area—originally a bus barn renovated for educational use— has supplemental wood joists installed between the steel roof purlins that are severely twisted and inadequately spliced, creating a high probability of structural failure under

PHOTO 10 - CTE ROOF STRUCTURE

significant snow or wind loads. While a formal structural analysis was outside the scope of this assessment, these observed conditions present potential life-safety concerns during severe weather events for this roof structure. I recommend that the district commissions a detailed structural engineering investigation to plan for necessary reinforcement or reframing.

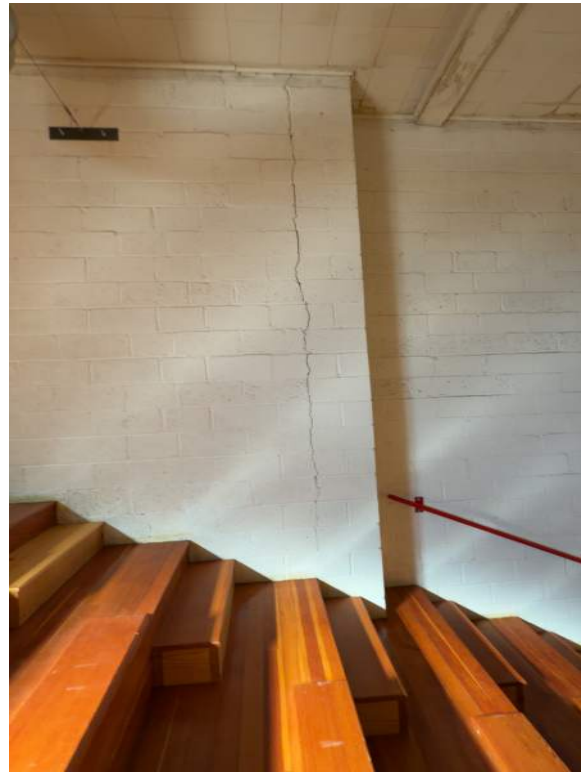
- 6. Gymnasium: A settlement crack was observed in the newer gymnasium. It is unknown how long this crack has been present (Photo 11).

PHOTO 11 - SETTLEMENT CRACK IN GYM

- 5) In the gymnasium where the settlement crack was noted, I recommend monitoring the crack for further movement.
